Publication date	25/08/2014
Document Nr.	SUPAIR_2014/08_003
Number of page	1/4

SAFETY NOTE

TOPIC : Webbing cut off by the edge of automatic buckle

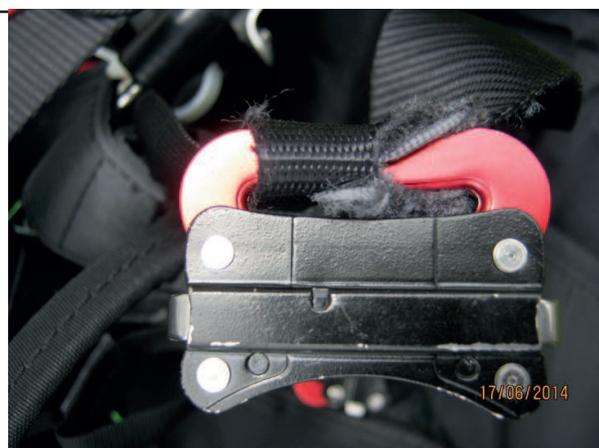
Unusual wear on strap passing through the female part of the 30mm automatic buckles (mainly used in chest closure) (pictured)

Some automatic buckles have sharp protrusions which may cause deterioration of the strap. This problem was solved, without delay following the finding of the problem

- **Do not fly with the harness affected**
- Take pictures of detected symptoms accompanied by an explanatory note and your contact information (Name, address, phone, email)

addressed by e-mail to the following address : sav@supair.com

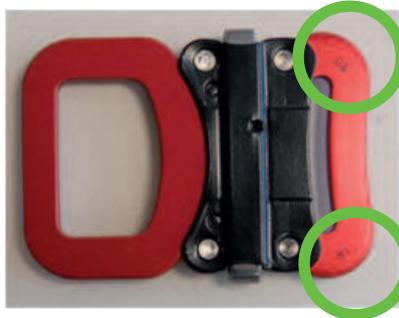
N° 05 / 12

Where to find the index on the automatic buckle ?

NOTE : if the index is not readable, would you like contact us

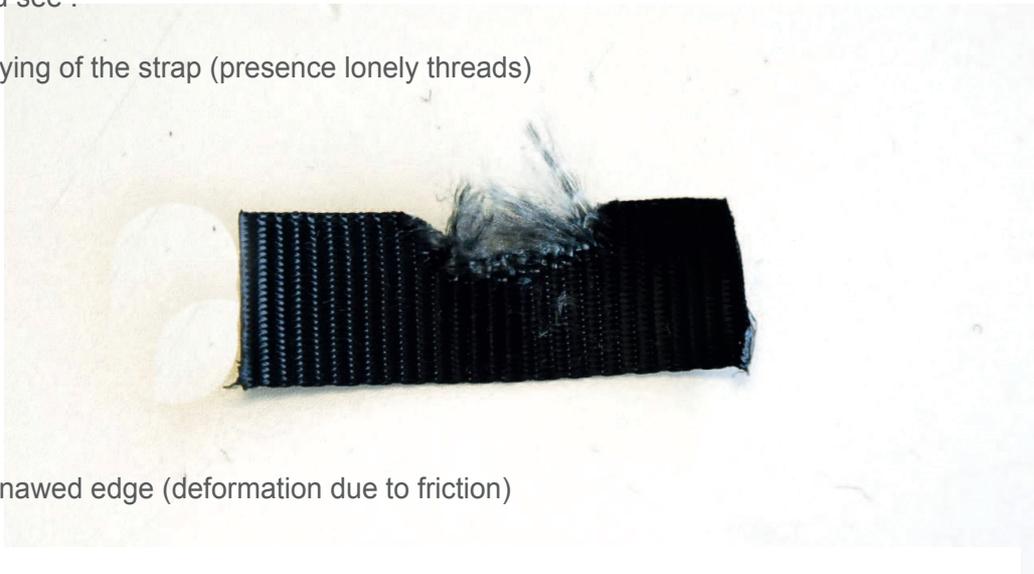
- Fraying of the strap (presence lonely threads)

- A gnawed edge (deformation due to friction)

=> So the harness may be damaged
