Published date	30/01/2019
Document number	SUPAIR_2019/01//001
Page number	1 / 2

Product lifespan / usage advice

ALTIRANDO 3

EVOLITE

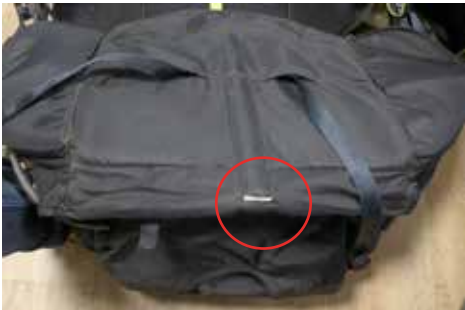
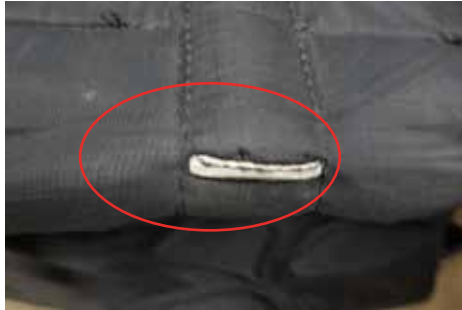
Risk of premature wear :

The fiberglass batten located beneath the seat may, in some instances, pierce the fabric.

The batten was placed inside its sleeve without protection, thus exposing one end with sharp edges.

Remove the batten :

Depending on the pilot's size, the batten may or not be useful.
Conduct a hang-test with and without the batten in place.

Contact us at sav@supair.com to receive a batten with two protective end caps corresponding to your harness model and size.

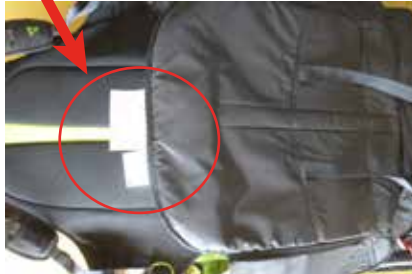
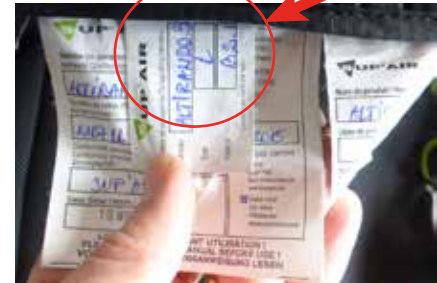
Harness ALTIRANDO 3

Index B2 to C1

Version C1.1 has been modified and does not pose a problem anymore.

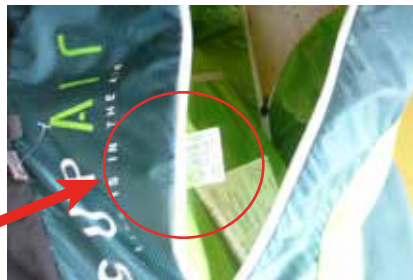
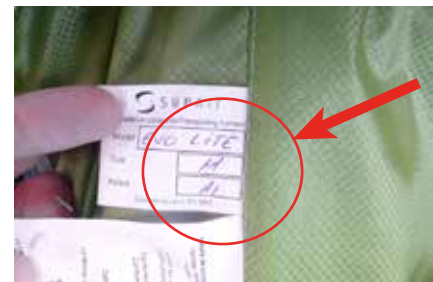
Harness EVOLITE

Index A1 à A8.

Version A8.1 has been modified and does not pose a problem anymore.
