Publishing date	07/11/2019
Document number	SUPAIR_2019_10_002_EN
Page number	1/1

SAFETY WARNING

SUBJECT : ACRO 4 Harness : Stitching Flaw

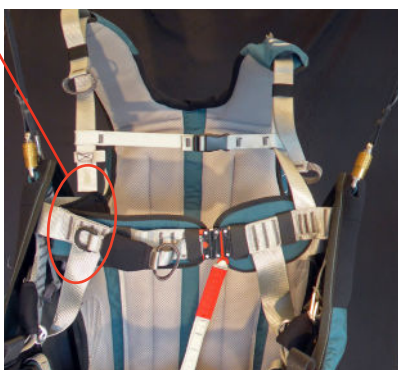
We have identified a problem at one of our client outlets wherein we found a harness missing safety stitching on a ACRO 4 harness produced in March 2019. One of the shoulder webbings was not correctly sewn with the ventral cross strap, but only pre-glued before the automatic manufacturing phase.

We are asking pilots using the ACRO 4 to verify that their shoulder straps are well sewn to the ventral straps (and not merely glued). Check for automatic vertical stitching (3 stitches) to the ventral strap.

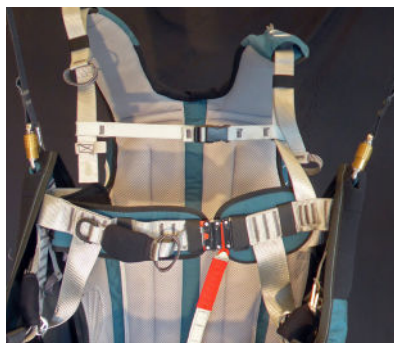
The 3 automatic vertical stitching are missing

DO NOT FLY!
Please contact
sav@supair.com
Do not use the harness until properly checked

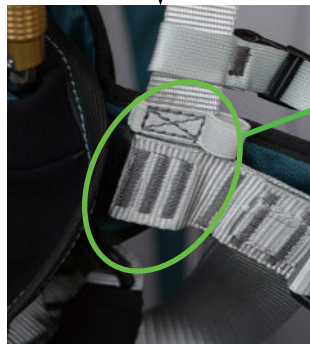
OK

The 3 automatic vertical stitching are there
