Date	May 20th 2013
Object	Safety Warning 2013/04 WALIBI LITE, WALIBI ² , EVASION ²

Replacing reserve parachute pocket elasicated cords

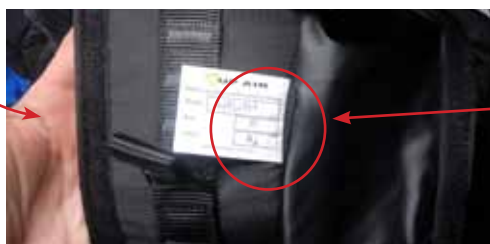
Label location

The code is found on the sewn label located under the right shoulder flap reserve parachute connection point.

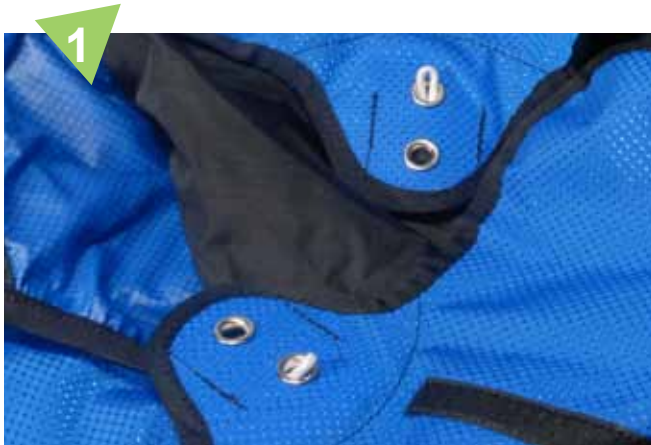
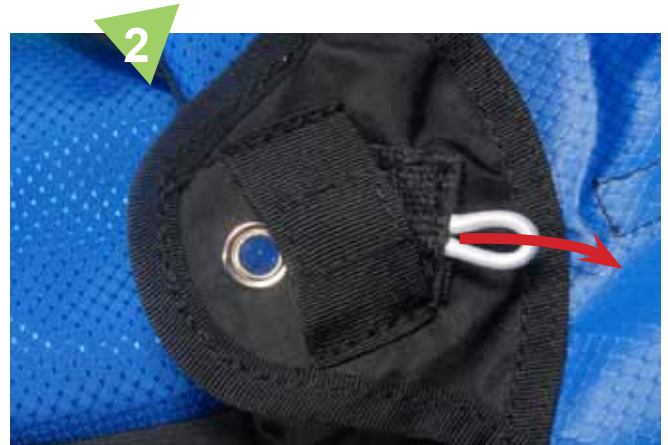
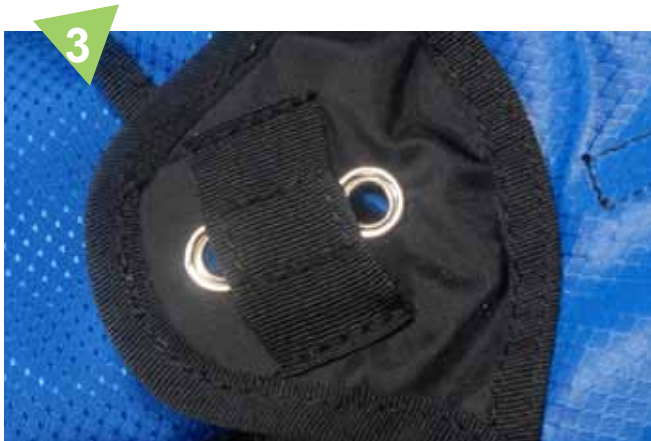
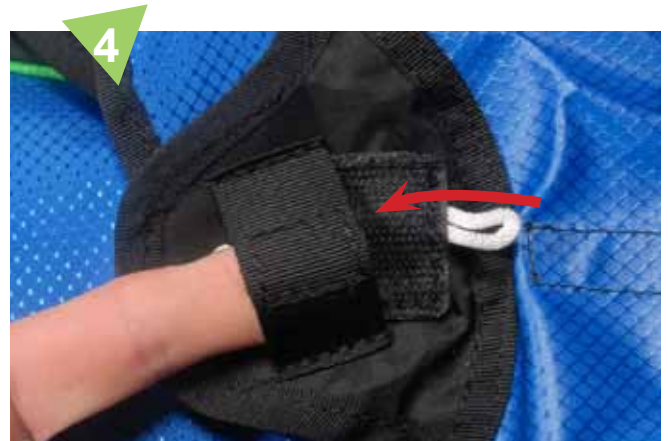
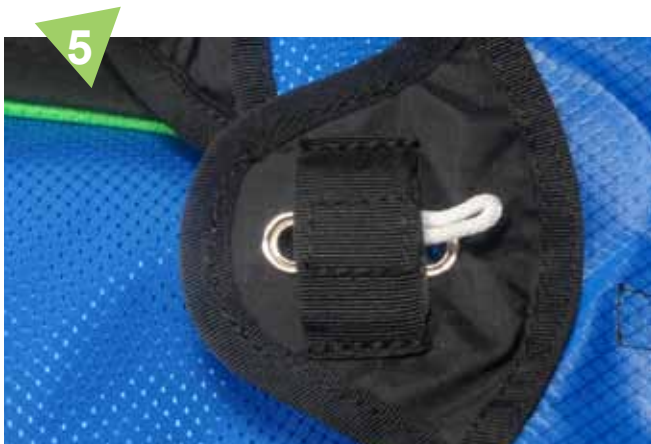
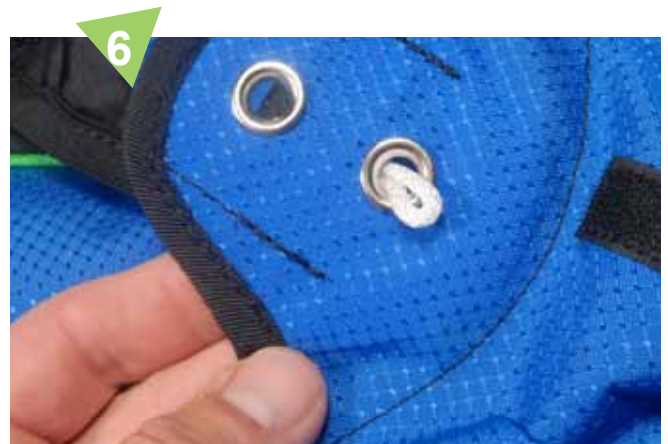
Replacing elasicated cords

The reserve parachute pocket elasicated cords could become weakened by the stitched line holding them in place. To avoid and prevent any premature wear- ing and risk of tearing of the aforementioned elasicated parts, we will suggest you to replace them by the cords included with this correspondence.
