Publication date	25/08/2014
Document Nr.	SUPAIR_2014/08_003
Number of page	1/4

SAFETY NOTE

TOPIC : Webbing cut off by the edge of automatic buckle

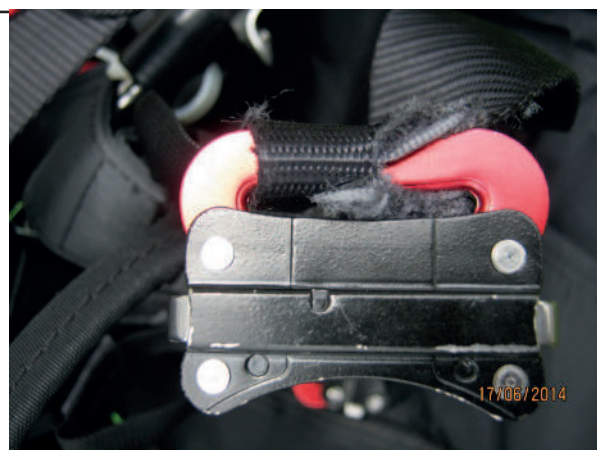
Unusual wear on strap passing through the female part of the 30mm automatic buckles (mainly used in chest closure) (pictured)

Some automatic buckles have sharp protrusions which may cause deterioration of the strap. This problem was solved, without delay following the finding of the problem

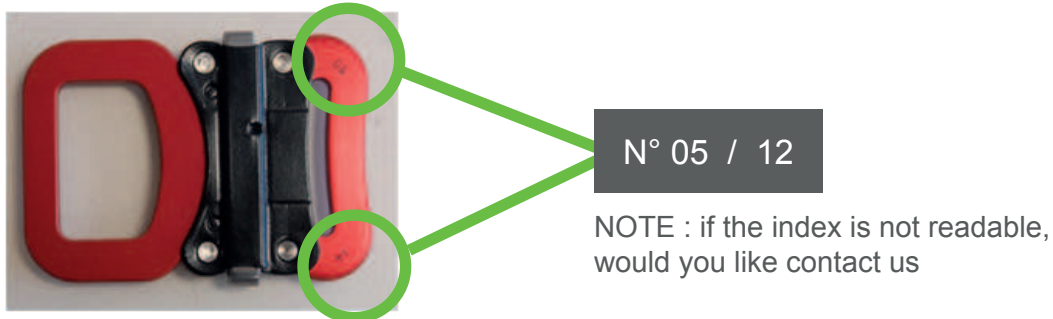
Where to find the index on the automatic buckle ?

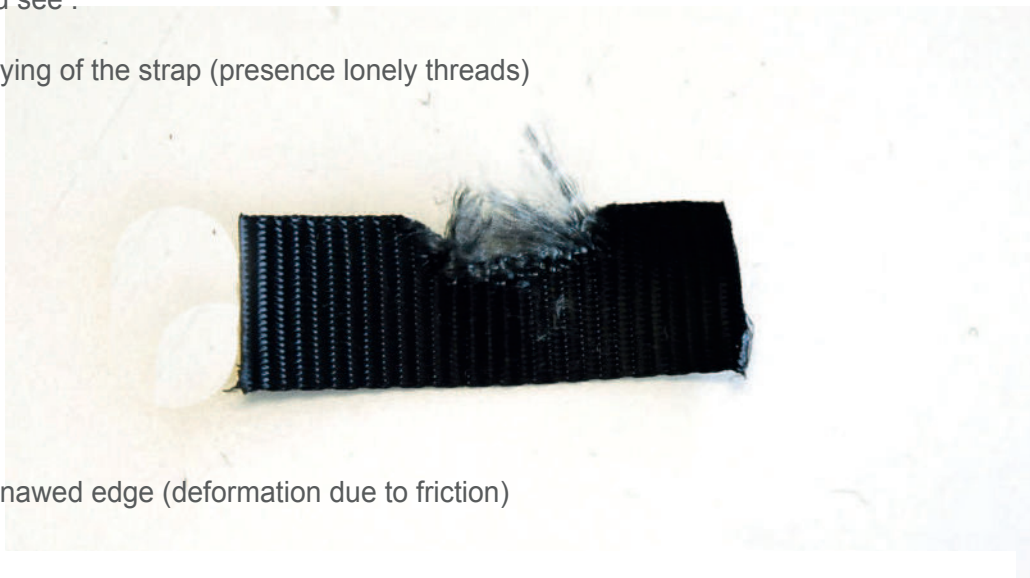
Observe the webbing strap in contact with the automatic buckle.
If you see :

- Fraying of the strap (presence lonely threads)

- A gnawed edge (deformation due to friction)

=> So the harness may be damaged

- **Do not fly with the harness affected**
- Take pictures of detected symptoms accompanied by an explanatory note and your contact information (Name, address, phone, email)
