Published date	13/02/2019
Document number	SUPAIR_2019/02/001
Page number	1 / 2

SUBJECT : Front reserve container standard

The coating on the rescue parachute container flaps might become sticky.

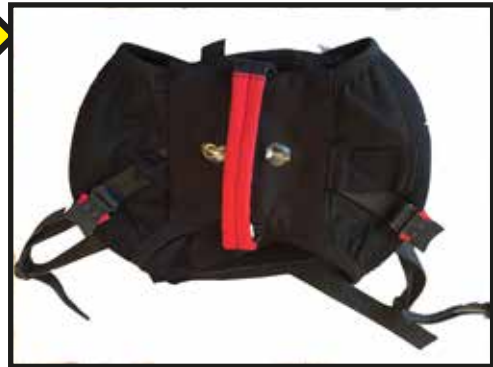
The coating of the black Cordura might deteriorate overtime and become sticky. It is possible that the degraded rescue parachute container flaps affect the parachute extraction, making it harder or even impossible.

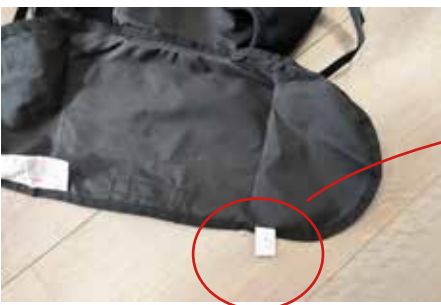
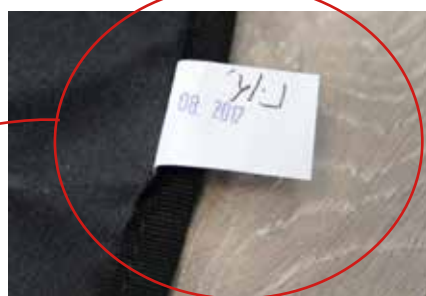
During their yearly parachute extraction test, several pilots noticed that the rescue parachute container flaps had become sticky.

(Fabric defect as regards to the stability of the coating overtime)
