### SUBJECT: STRIKE Harness

Tear in leg strap side panels

Safety Warning : SUPAIR\_2017/06\_001

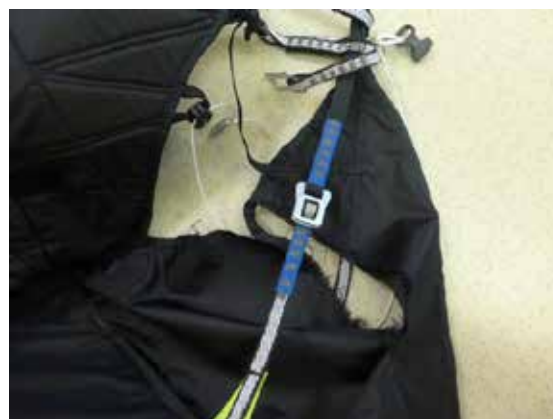
It is possible that tears could appear in the side panels when high G force is applied

Some tears occurred in the side panel during hard spiral dives or other manoeuvres with high G force. The tears do not compromise the structure of the harness but may destabilise the pilot in the harness during and after the manoeuvre and the harness might become uncomfortable to fly.

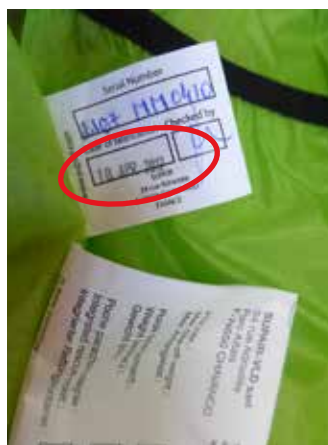
Recto

Open the back storage compartment  
The production index is on the small label
