CALL FOR INSPECTION : PARACHUTE BRIDLES

- Solo Dyneema parachute bridles REF : ELESOLODYNEEMA
- Tandem Y Dyneema parachute bridles REF : ELEBIY
- Tandem H Dyneema parachute bridles REF : ELEBIH

Possible absence of a safety seam on solo or tandem parachute bridles

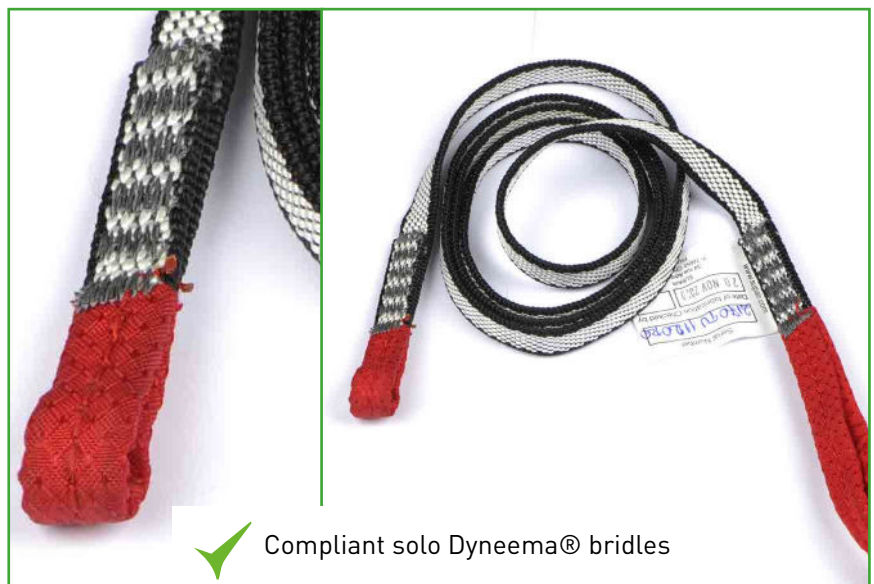
You need to check for the presence of this seam (grey thread) as shown in the following photo. To do this, you must have access to the riser attachment points on the harness and the parachute.

Compliant solo Dyneema® bridles

Check on **EACH SIDE** of **EACH LOOP**
that the seam is present **AND** complete with 5 or 6 distinct ways of stitches

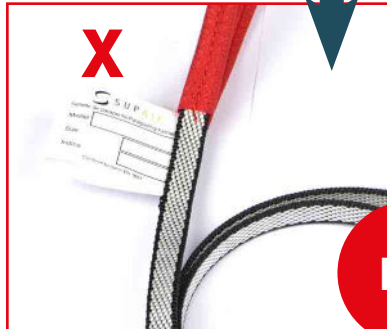
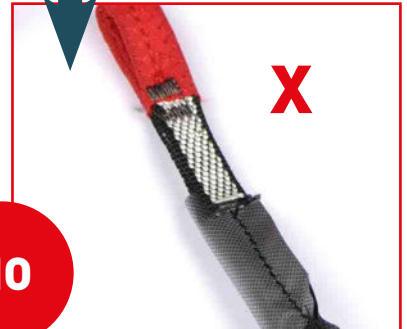
NO

We had 4 customers reporting that one of their parachute bridles is missing a safety seam. As a precautionary measure, we ask that you inspect your bridles.

I immediately remove and isolate the bridles
I contact the supair customer service

If you have detected a missing seam, remove the affected bridle, cut it in half (to make sure you do not use it again). Take a photo of the non-conforming bridle cut in half. Contact SUPAIR's after-sales service by email with the photo. As soon as we receive your email, we will send you a new pair of bridles free of charge as soon as possible. If you wish, you can also return the bridle concerned to the following address :
