Publication date	21/10/2015
Document nr.	SUPAIR_2015/10_001
Number of page	1 / 4

## SAFETY NOTE

TOPIC : ALTIRANDO2RS rescue handle release

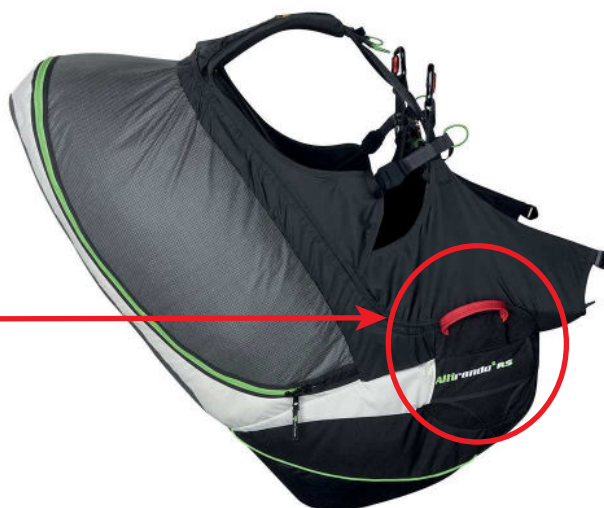
Pulling the handle might be more difficult than expected in certain cases, slowing down deployment of the reserve.

During a hang test, we noted some difficulties in removing the rescue handle from the housing. This is due to the presence of a velcro strap on one of the rescue pocket folds.

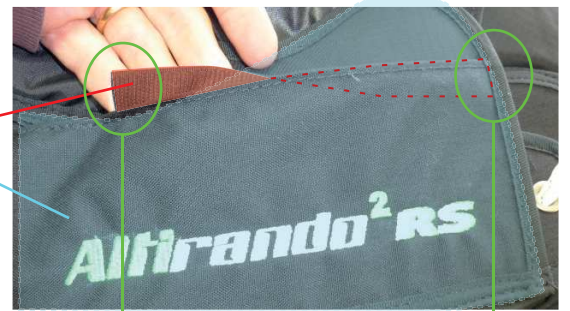
- 1 Identify the flap where the velcro is sewn :  
"Altirando2 RS" embroidered flap

Identify the sewn Velcro

"A" Extremity

"B" Extremity
