Publication date	20/07/2015
Document nr.	SUPAIR_2015/07_001
Number of page	1 / 5

SAFETY NOTE

TOPIC : Unusual wear on leg strap.

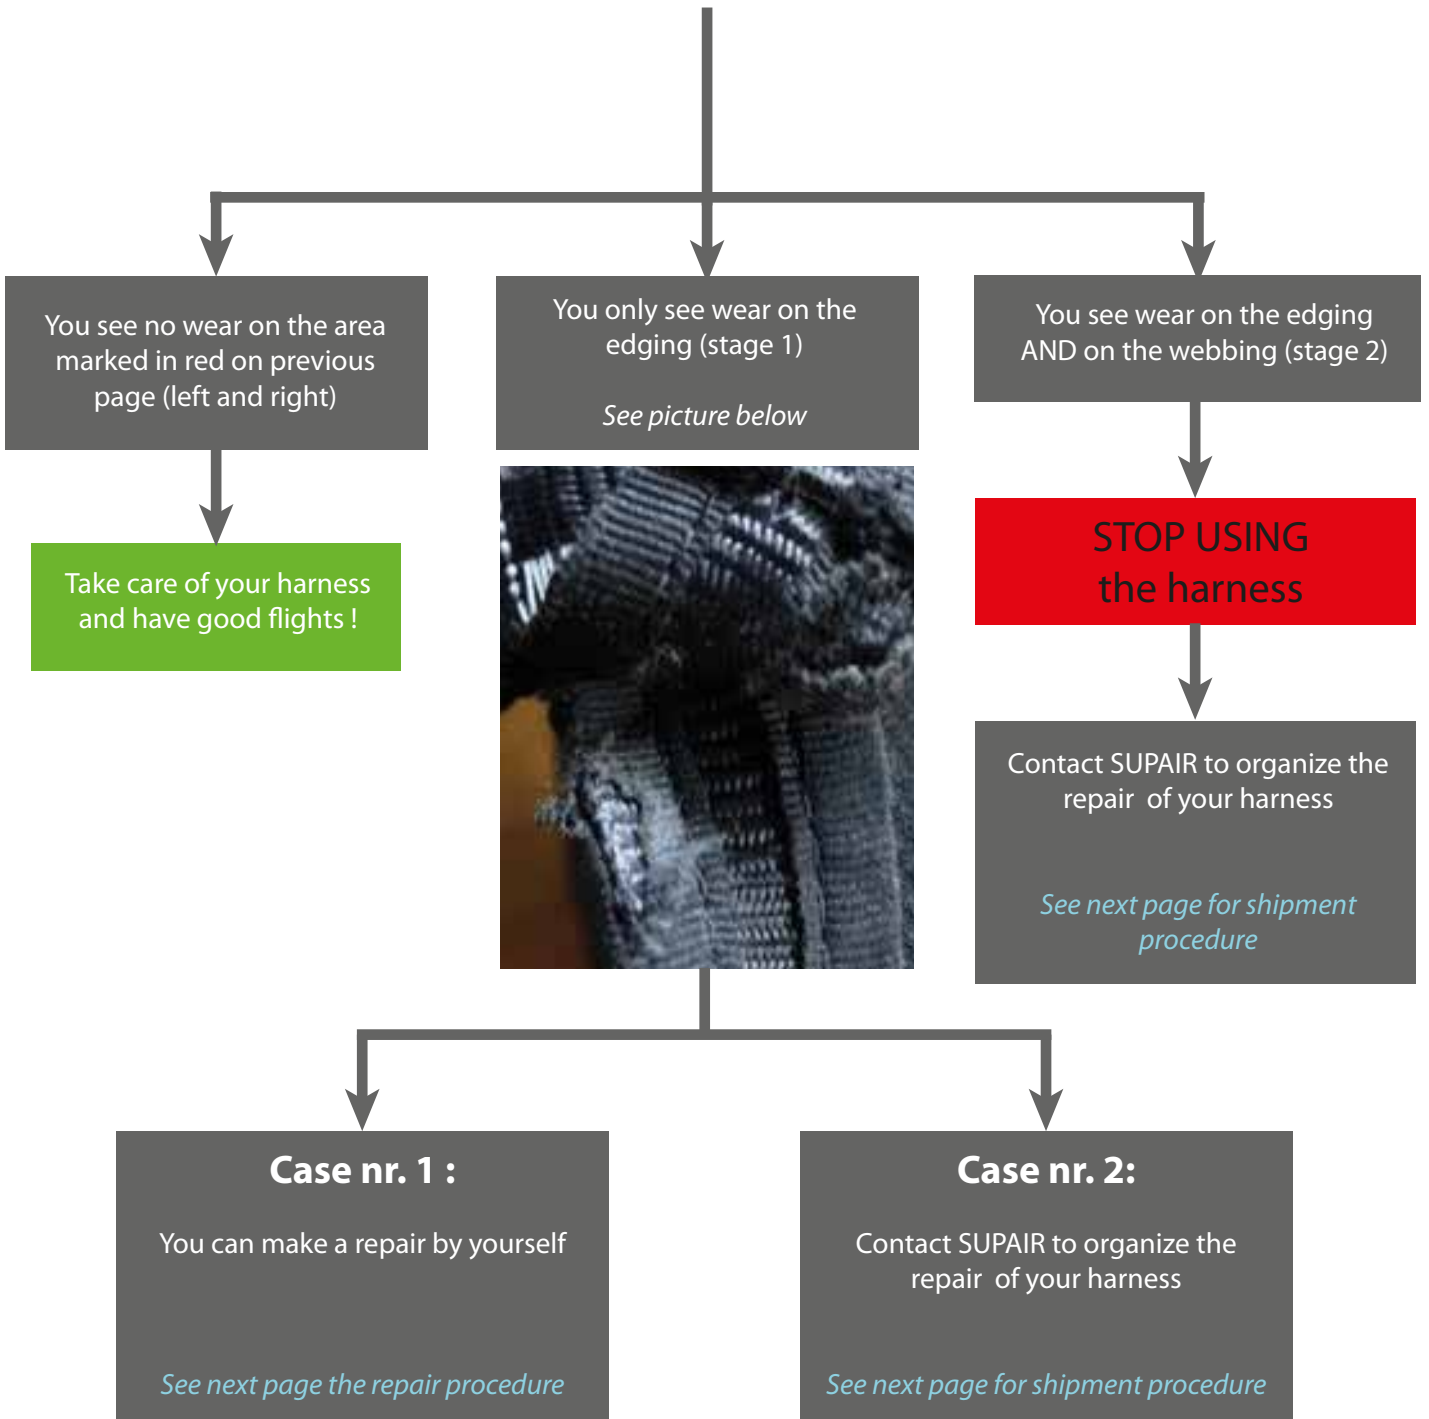
Premature wear and tear can be detected on the leg straps.

Signs of wear and tear appear in two stages : firstly on the edging, secondly, after some time, on the webbing itself.

The purpose of repair is to protect the structural strap from the wear caused by the end of the "webbing return" (blue circle).

To make the protection, you have to roll a piece of thin webbing around the end of the leg «strap return». Sew the system to secure the repair.
