## EVO LITE INFORMATION

January 8th, 2021

**Harnesses concerned:** EVOLITE index A1 to A9

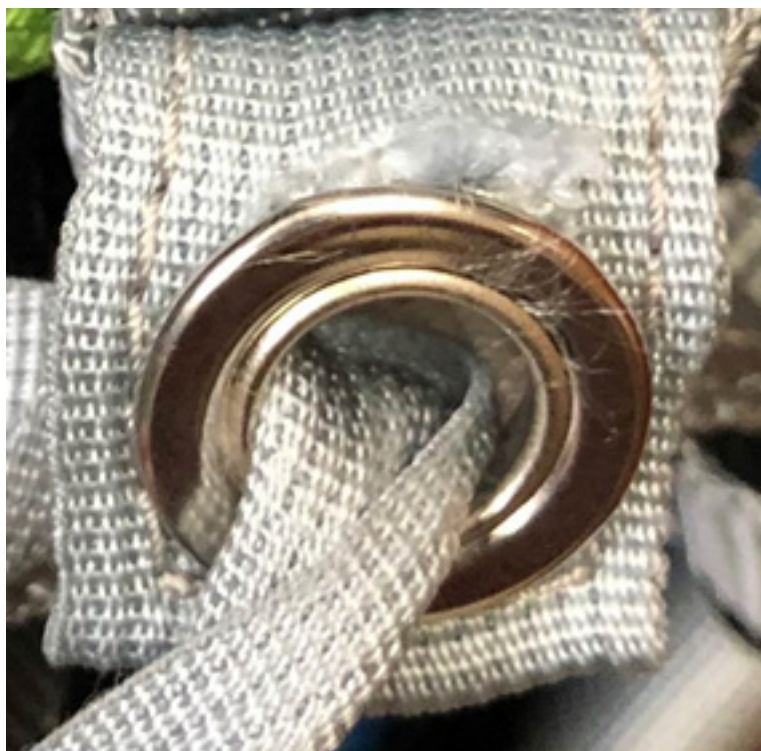
## STRAP NOT REQUIRING A REINFORCEMENT KIT

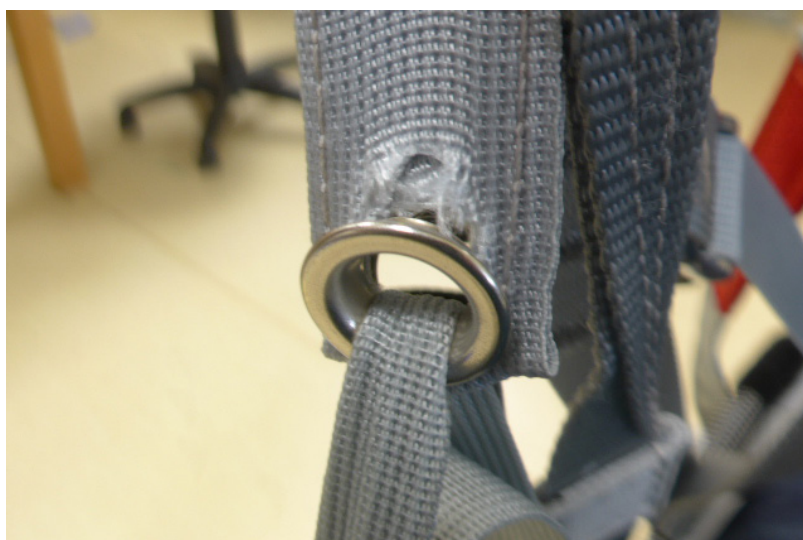
## STRAP REQUIRING A REINFORCEMENT KIT

For pilots who notice a weakness in the eyelet's hold, we propose to send you a reinforcement kit to be fixed on the links.
